# RESIDENTIAL PROPERTY INSPECTION

1234 Main Street FALL BRANCH, TN 37656

> Buyer Name 12/10/2023 9:00AM

Inspector KC Bartley

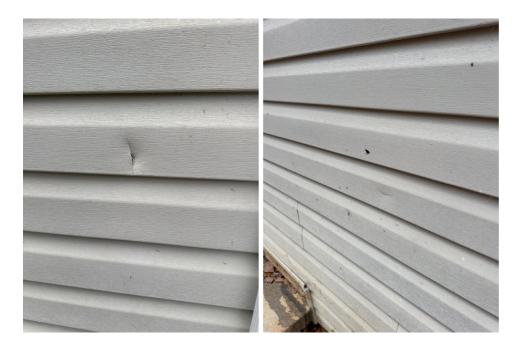
5.3.1 Vinyl Siding

#### **VINYL SIDING - DAMAGE**

Recommendation

Contact a qualified siding specialist.

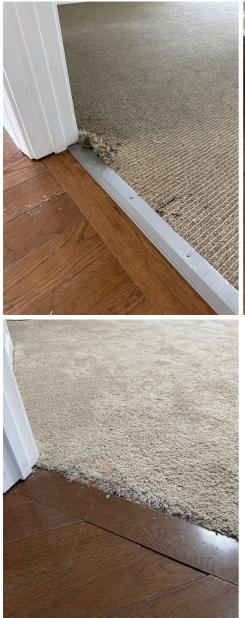
8.8.1 Floor Condition

#### **HARDWOOD - DAMAGE**

Recommendation

Contact a qualified flooring contractor

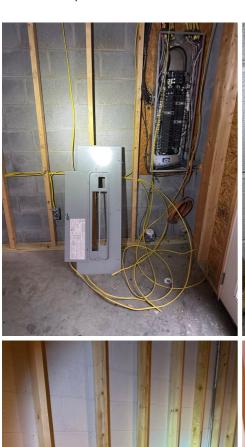
13.6.1 Service Grounding/Bonding

#### WATER PIPE BONDING - MISSING/NOT VISIBLE

Recommendation

Contact a qualified electrical contractor.

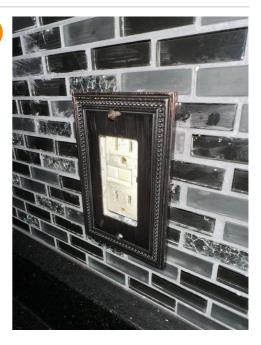
13.10.1 Receptacles

# RECEPTACLES - DIFFICULT TO "PLUG INTO"

Recommendation

Contact a qualified electrical contractor.

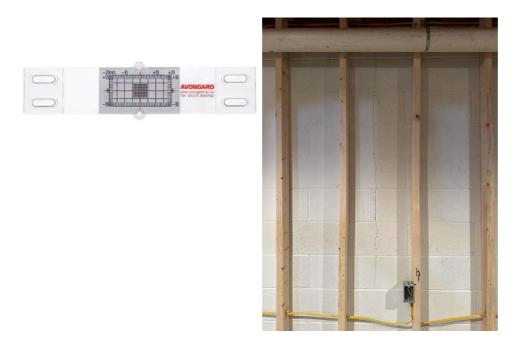
17.5.1 Foundation Walls - CSM

### **CRACKING - WITHIN NORMAL TOLERANCES**

For more information on any crack(s), an evaluation is recommended to be performed by a structural engineer. \*Please read the information & limitations in regards to cracking above.
